Lubricant Plant Solves Long-Standing Corrosion Problem Aided by Monitoring Program

Rosemount™ Wireless Permasense™ Corrosion and Erosion Monitoring using Adaptive Cross Correlation Processing applied to lubricant reprocessing.

Petrochemical plant, central Russia

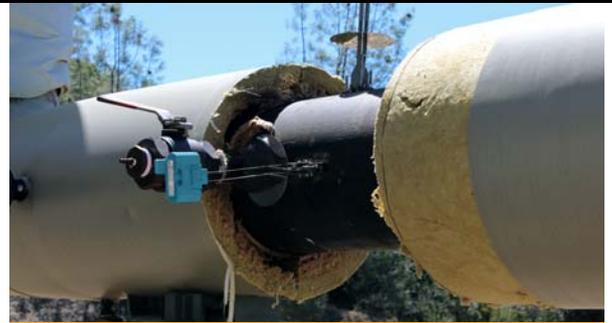
Operators tried to take manual pipe wall thickness readings using portable ultrasonic measuring devices, but these proved ineffective due to the low repeatability characteristic of the technique, combined with access difficulties.

While operators tried to take manual pipe wall thickness readings using portable ultrasonic measuring devices, these proved ineffective due to the low repeatability characteristic of the technique, combined with access difficulties. This forced operators to shut down the system multiple times each year to break apart the piping in strategic spots for manual inspection. Any required piping replacement extended the shutdowns.
